SHIPPING AND STORAGE CONTAINER MARK 398 MOD 0

(FOR BOMB, CHEMICAL, MARK 116 MOD 0)

DEVELOPMENT, TEST, AND EVALUATION

1 OCT 1964

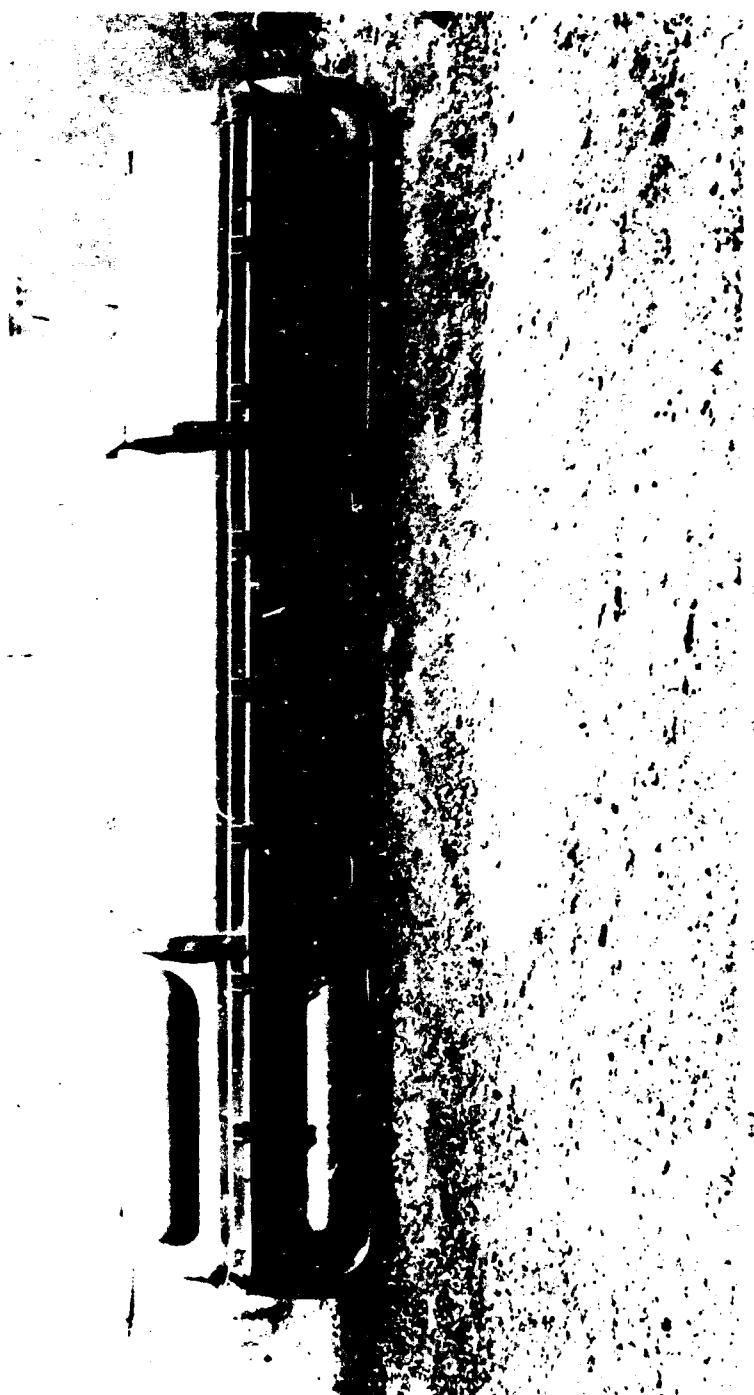
3.1 Description of container. Shipping and Storage Container, Mark 398 Mod 0, DL 1516771, shown in Figure 1, is a reusable container designed to contain one agent-filled, Chemical Bomb, Mark 116 Mod 0 (less bursters and nose fuze assembly).

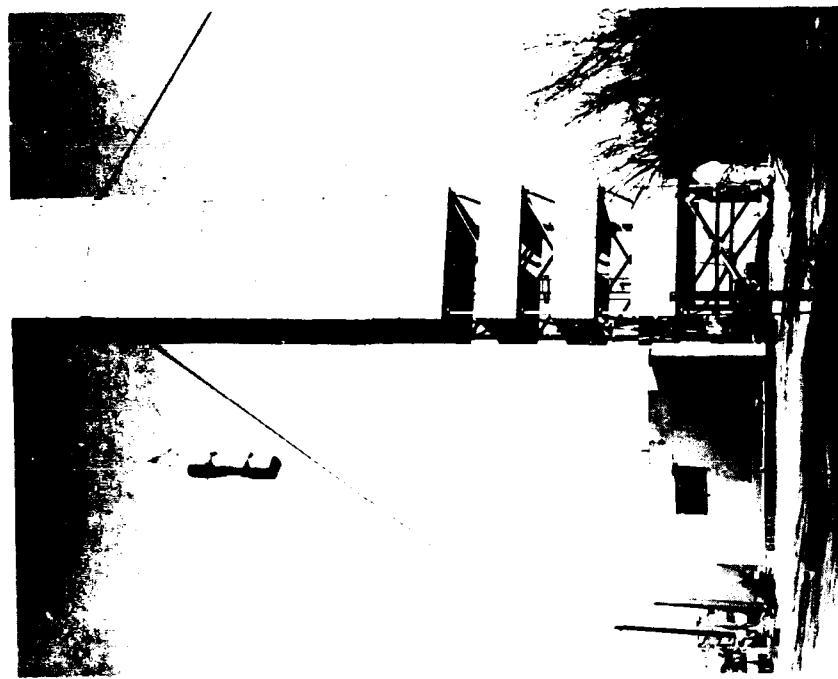
Figure 3. Container in position for 10-foot end drop-test.

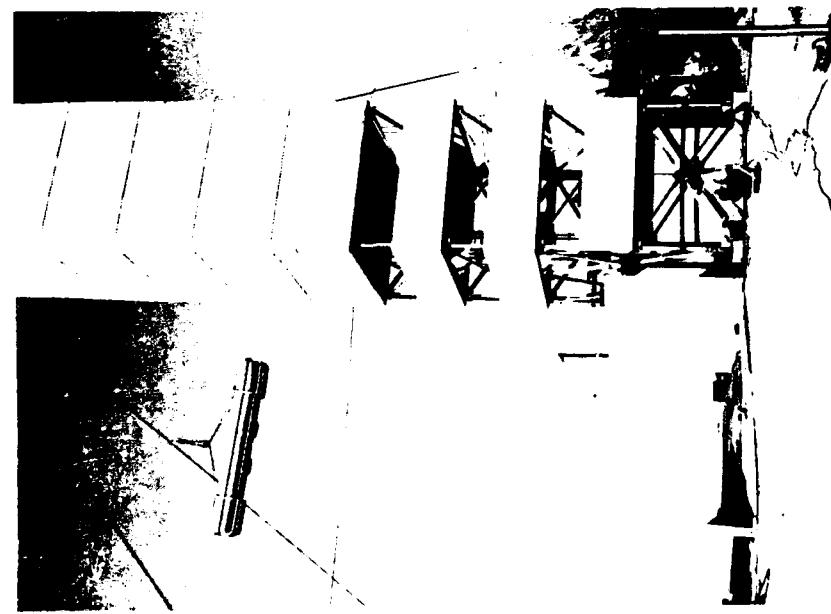
Figure 2. Container in position for 10-foot bottom drop-test.

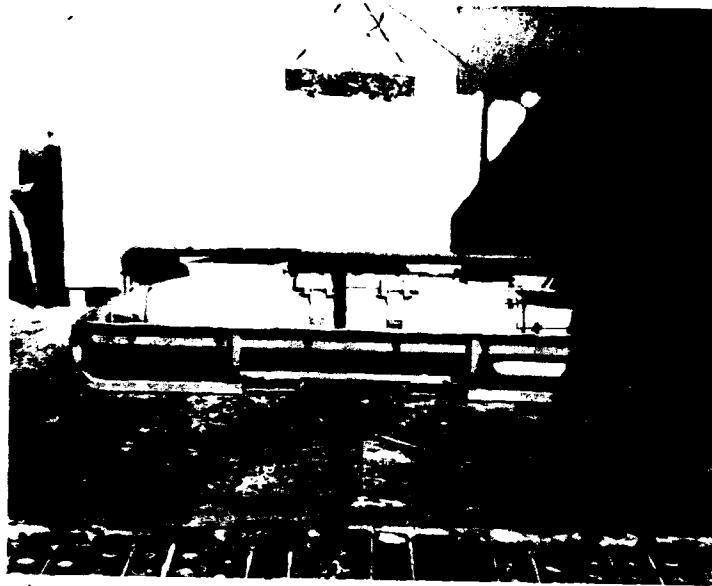
The first drop performed in this series was a 40-foot drop in the horizontal position. The container was loaded with a rejected bomb, serial number 7, which was wrapped in sufficient expanded bead polystyrene to form a tight pack. (See Figure 6.) The bomb was water filled and self-recording accelerometers attached. Weight of the loaded container was 830 pounds. Shock loads recorded at impact were: bomb, 520 g, and the container, 600 g. Only minor damage was caused to the bomb, 3 fins were sprung free from the retaining ring and the fourth was forced against the container, the bomb did not leak and was "safe-to-dispose". The container damage consisted of a broken swing bolt, the gasket flange was distorted and some tearing of the packing. (See Figure 7.)

Figure 6. Container and bomb after drop-test number 1, resilient material used for restraint.

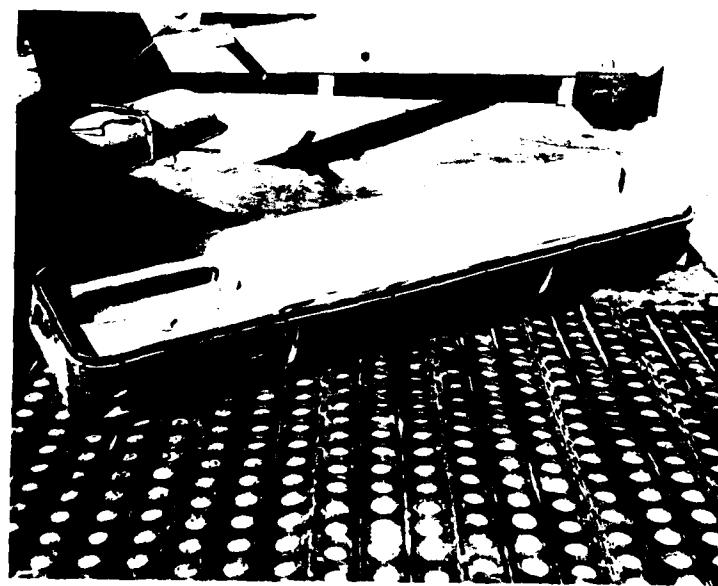
Figure 7. Container after drop-test number 2.

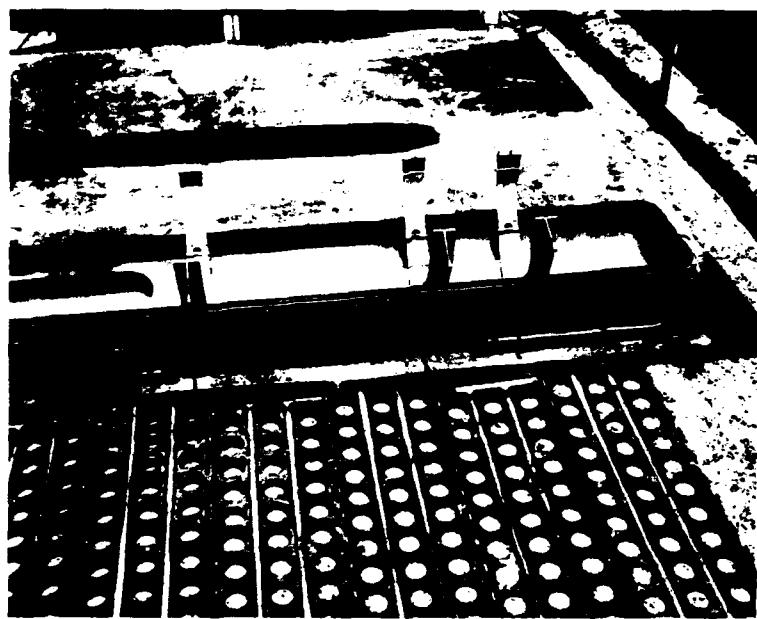
July 19, 1963, drop-test number 2: this was a 10-foot end drop. The container was equipped with three 3-inch-wide straps lined with coarse cotton webbing. (See Figure 8.) The bomb used was serial number 50 and was water filled to a total weight of 505 pounds. After installing the bomb in the saddles, the strap assembly T bolts were torqued 200 inch pounds. Self-recording accelerometers were installed. Impact was on the forward end, shock loads to the container were 790 g and 250 g to the bomb. Damage to the bomb was:

Figure 6. Lower shell of container in saddle and strap configuration.

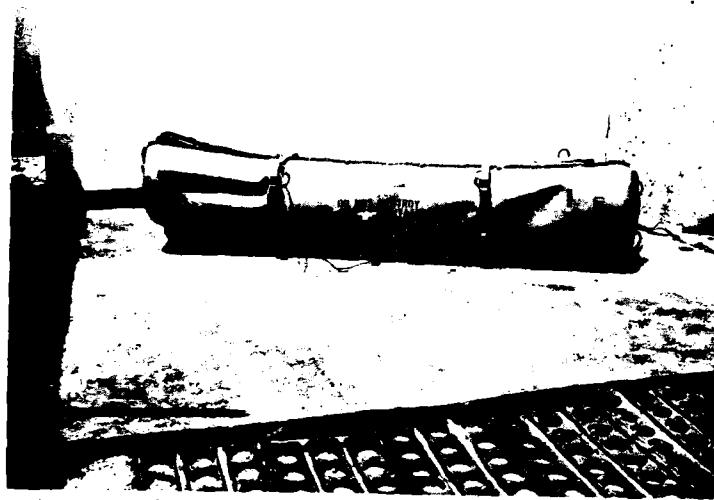
Drop number 3 was performed on July 19, 1963, and was intended to be a 40-foot horizontal drop. Due to a hesitation of the release mechanism, the container was oriented 45 degrees at impact. The container was equipped with two 3-inch-wide straps, the strap T bolts were torqued to 250 inch pounds. Bomb number 50 was water filled and used again in this test. Two accelerometers were installed. The shock level to the container was 730 g and to the bomb 400 g. The bomb was subjected to only incidental damage, no leakage was evident and the bomb was "safe-to-dispose". The container received extensive deformation (see Figures 10 and 11). Slippage of the bomb in the container was minimal and the capability of the container to protect the store from end shocks was evident.

figure 10. Container damage after 40-foot, forty-five degree drop-test.

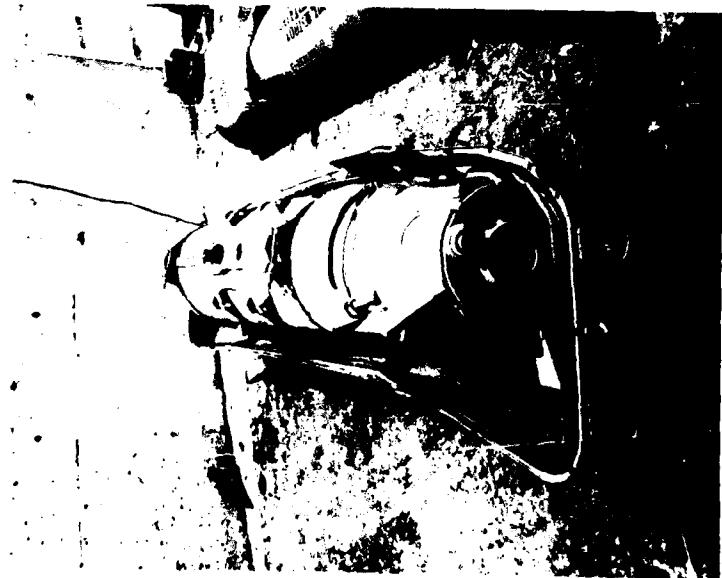
figure 11. Container and bomb damage caused after 40-foot, forty-five degree drop-test.

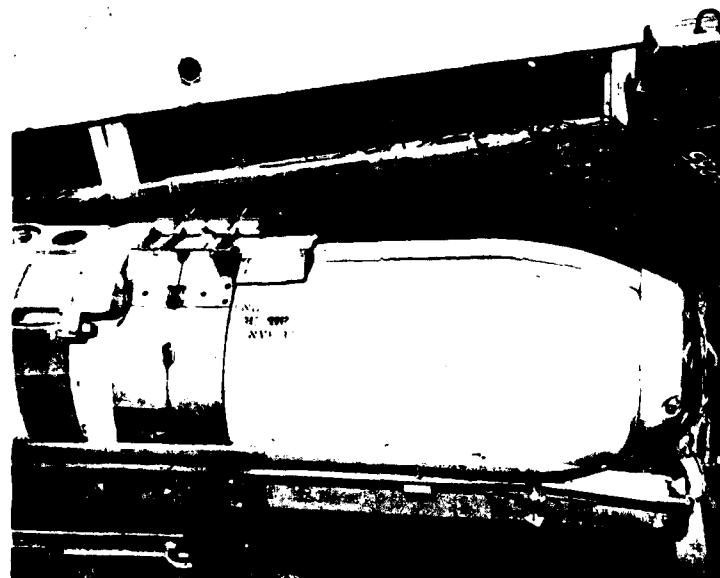
Drop number 4, September 27, 1963, was the first 40-foot end drop. The impact surface was the forward or nose end. The container used incorporated two 6-inch-wide straps, each having two T bolts and utilizing a bridge plate in an effort to increase the surface friction to the bomb. Bomb number 50, water filled to simulate actual weight, was used again. Self-recording accelerometers were positioned as in previous test. The bomb received a 550 g shock and the container shock was near 800 g. Damage to the bomb was minor (see Figures 12 and 13). The fins were sprung free of their retainers and the upper saddle assembly was forced aft slightly. Leakage was not evident and the bomb was "safe-to-dispose". The container was rendered unserviceable since the nose end was deformed approximately 3 inches. The straps afforded adequate restraint, one bridge plate was dislocated from the strap. The container required minimum effort to open and the store was easily removed.

Figure 13. Container and bomb damage caused by 40-foot nose down end drop-test.

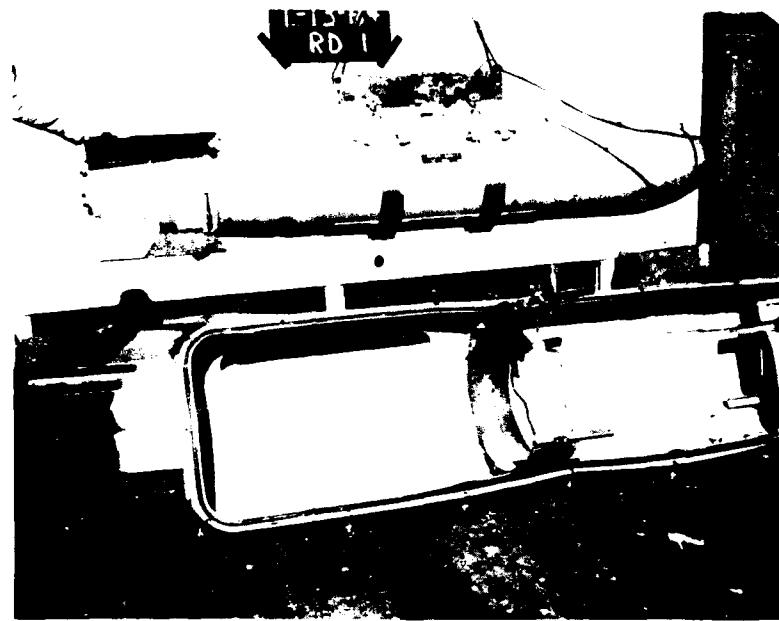
was used. Shock levels were not recorded on this test. Deformation of the gasket flanges was the major damage to the container. The bomb received abrasions on the nose and a small cut to bottom (see Figure 14). The cut was caused by impact with the flooding void and only a small seepage was apparent. Corrective action was to remove the flooding void from the lower shell of the container.

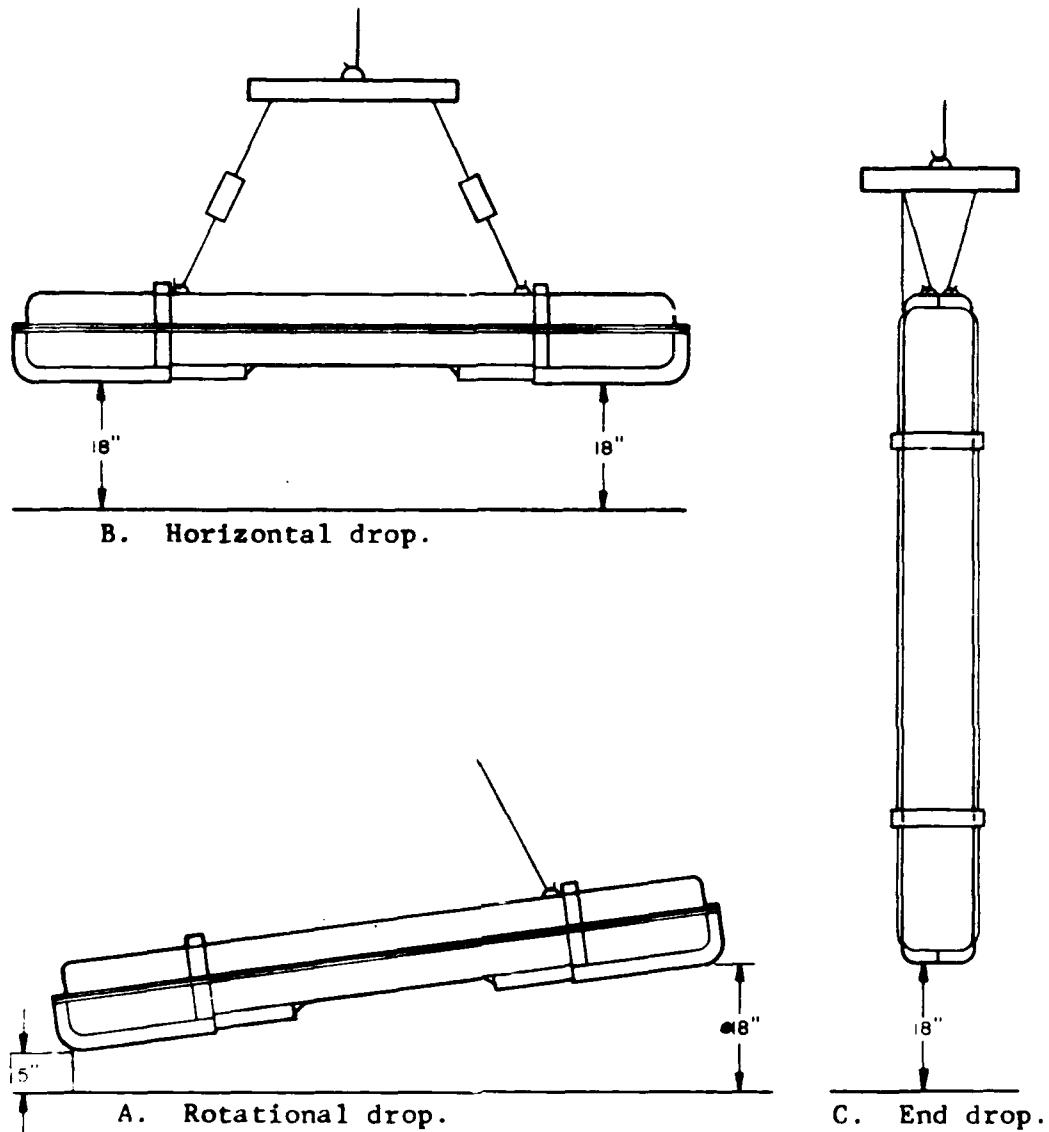
5.1.2 Rotational drop test. The rotational drop tests were conducted with a pressurized container containing a ethylene-glycol filled bomb, the container was pressurized to 15 psig. The container was positioned with one corner suspended 18 inches above the impact surface (see Figure 28A). Each bottom corner was subjected to an impact, no damage was experienced by either the container or the bomb and no loss of air pressure occurred.

5.1.3 Free fall drop test. Eighteen-inch free fall drops were made from two positions: one drop in the horizontal position impacting on the bottom, and one drop in the vertical position impacting on the forward end (see Figures 28B and 28C). The container was loaded with an ethylene-glycol filled bomb for each of these tests, gross weight of the loaded container was 865.5 pounds. Neither of the drops produced damage to the bomb.

Figure 28. Container positions for WR-11 rough handling test.
